TECHNICAL REPORT HL-79-19

# NAVIGATION CONDITIONS AT LOCKS AND DAM 26, MISSISSIPPI RIVER

Hydraulic Model Investigation

Prepared for U. S. Army Engineer District, St. Louis  
St. Louis, Missouri 63101

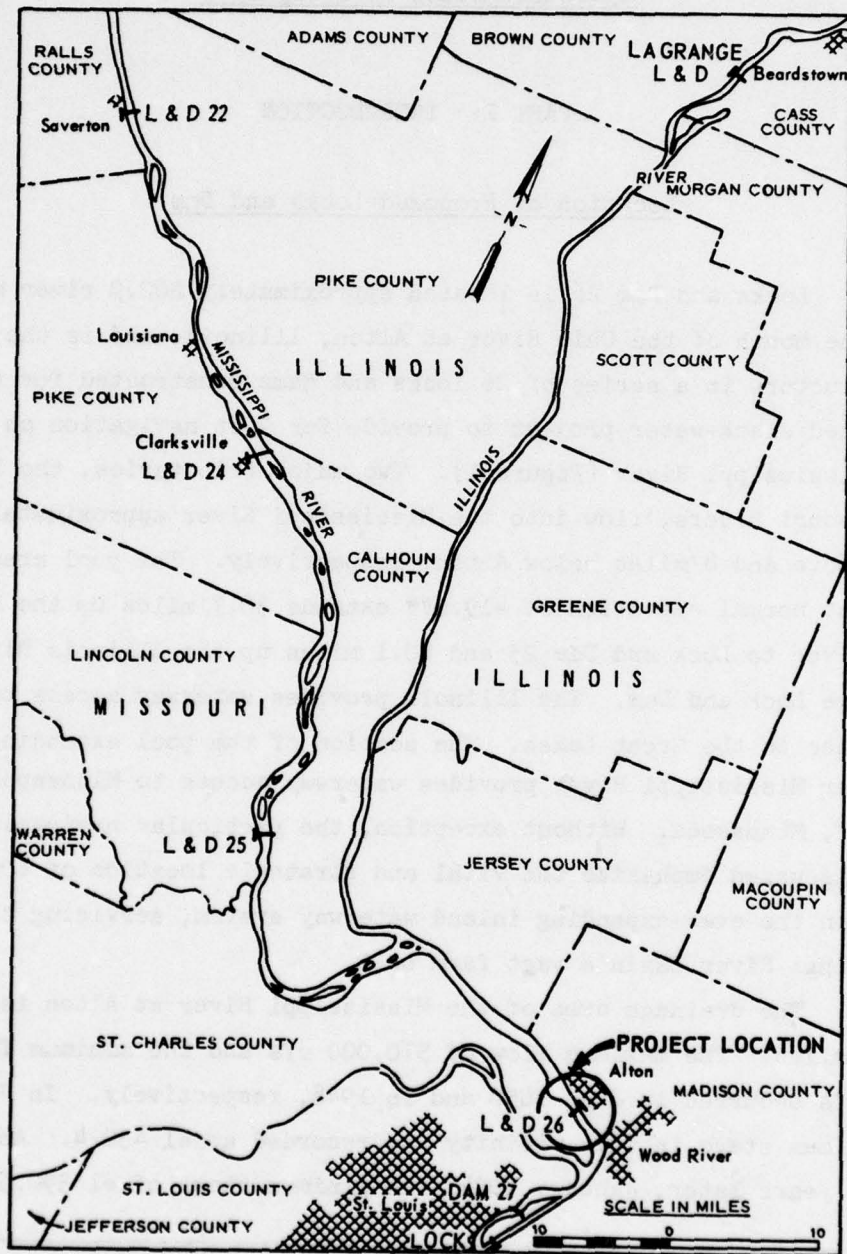
Figure 1. Vicinity map

1. Locks and Dam 26 is located approximately 202.9 river miles\* above the mouth of the Ohio River at Alton, Illinois, and is the lowermost structure in a series of 26 locks and dams constructed for the authorized slack-water project to provide for 9-ft navigation on the upper Mississippi River (Figure 1). Two major tributaries, the Illinois and Missouri Rivers, flow into the Mississippi River approximately 15 miles above and 8 miles below Alton, respectively. The pool created by Dam 26 at normal elevation of 419.0\*\* extends 38.7 miles up the Mississippi River to Lock and Dam 25 and 80.1 miles up the Illinois River to La Grange Lock and Dam. The Illinois provides waterway access to Chicago and thence to the Great Lakes. The section of the pool extending into the upper Mississippi River provides waterway access to Minneapolis and St. Paul, Minnesota. Without exception, the particular navigation projects discussed emphasize the vital and strategic location of Locks and Dam 26 in the ever-expanding inland waterway system, servicing the upper Mississippi River Basin's vast farm belt.
